WATER POLLUTION SURVEY

VILLAGE OF MARMORA

COUNTY OF HASTINGS

1965

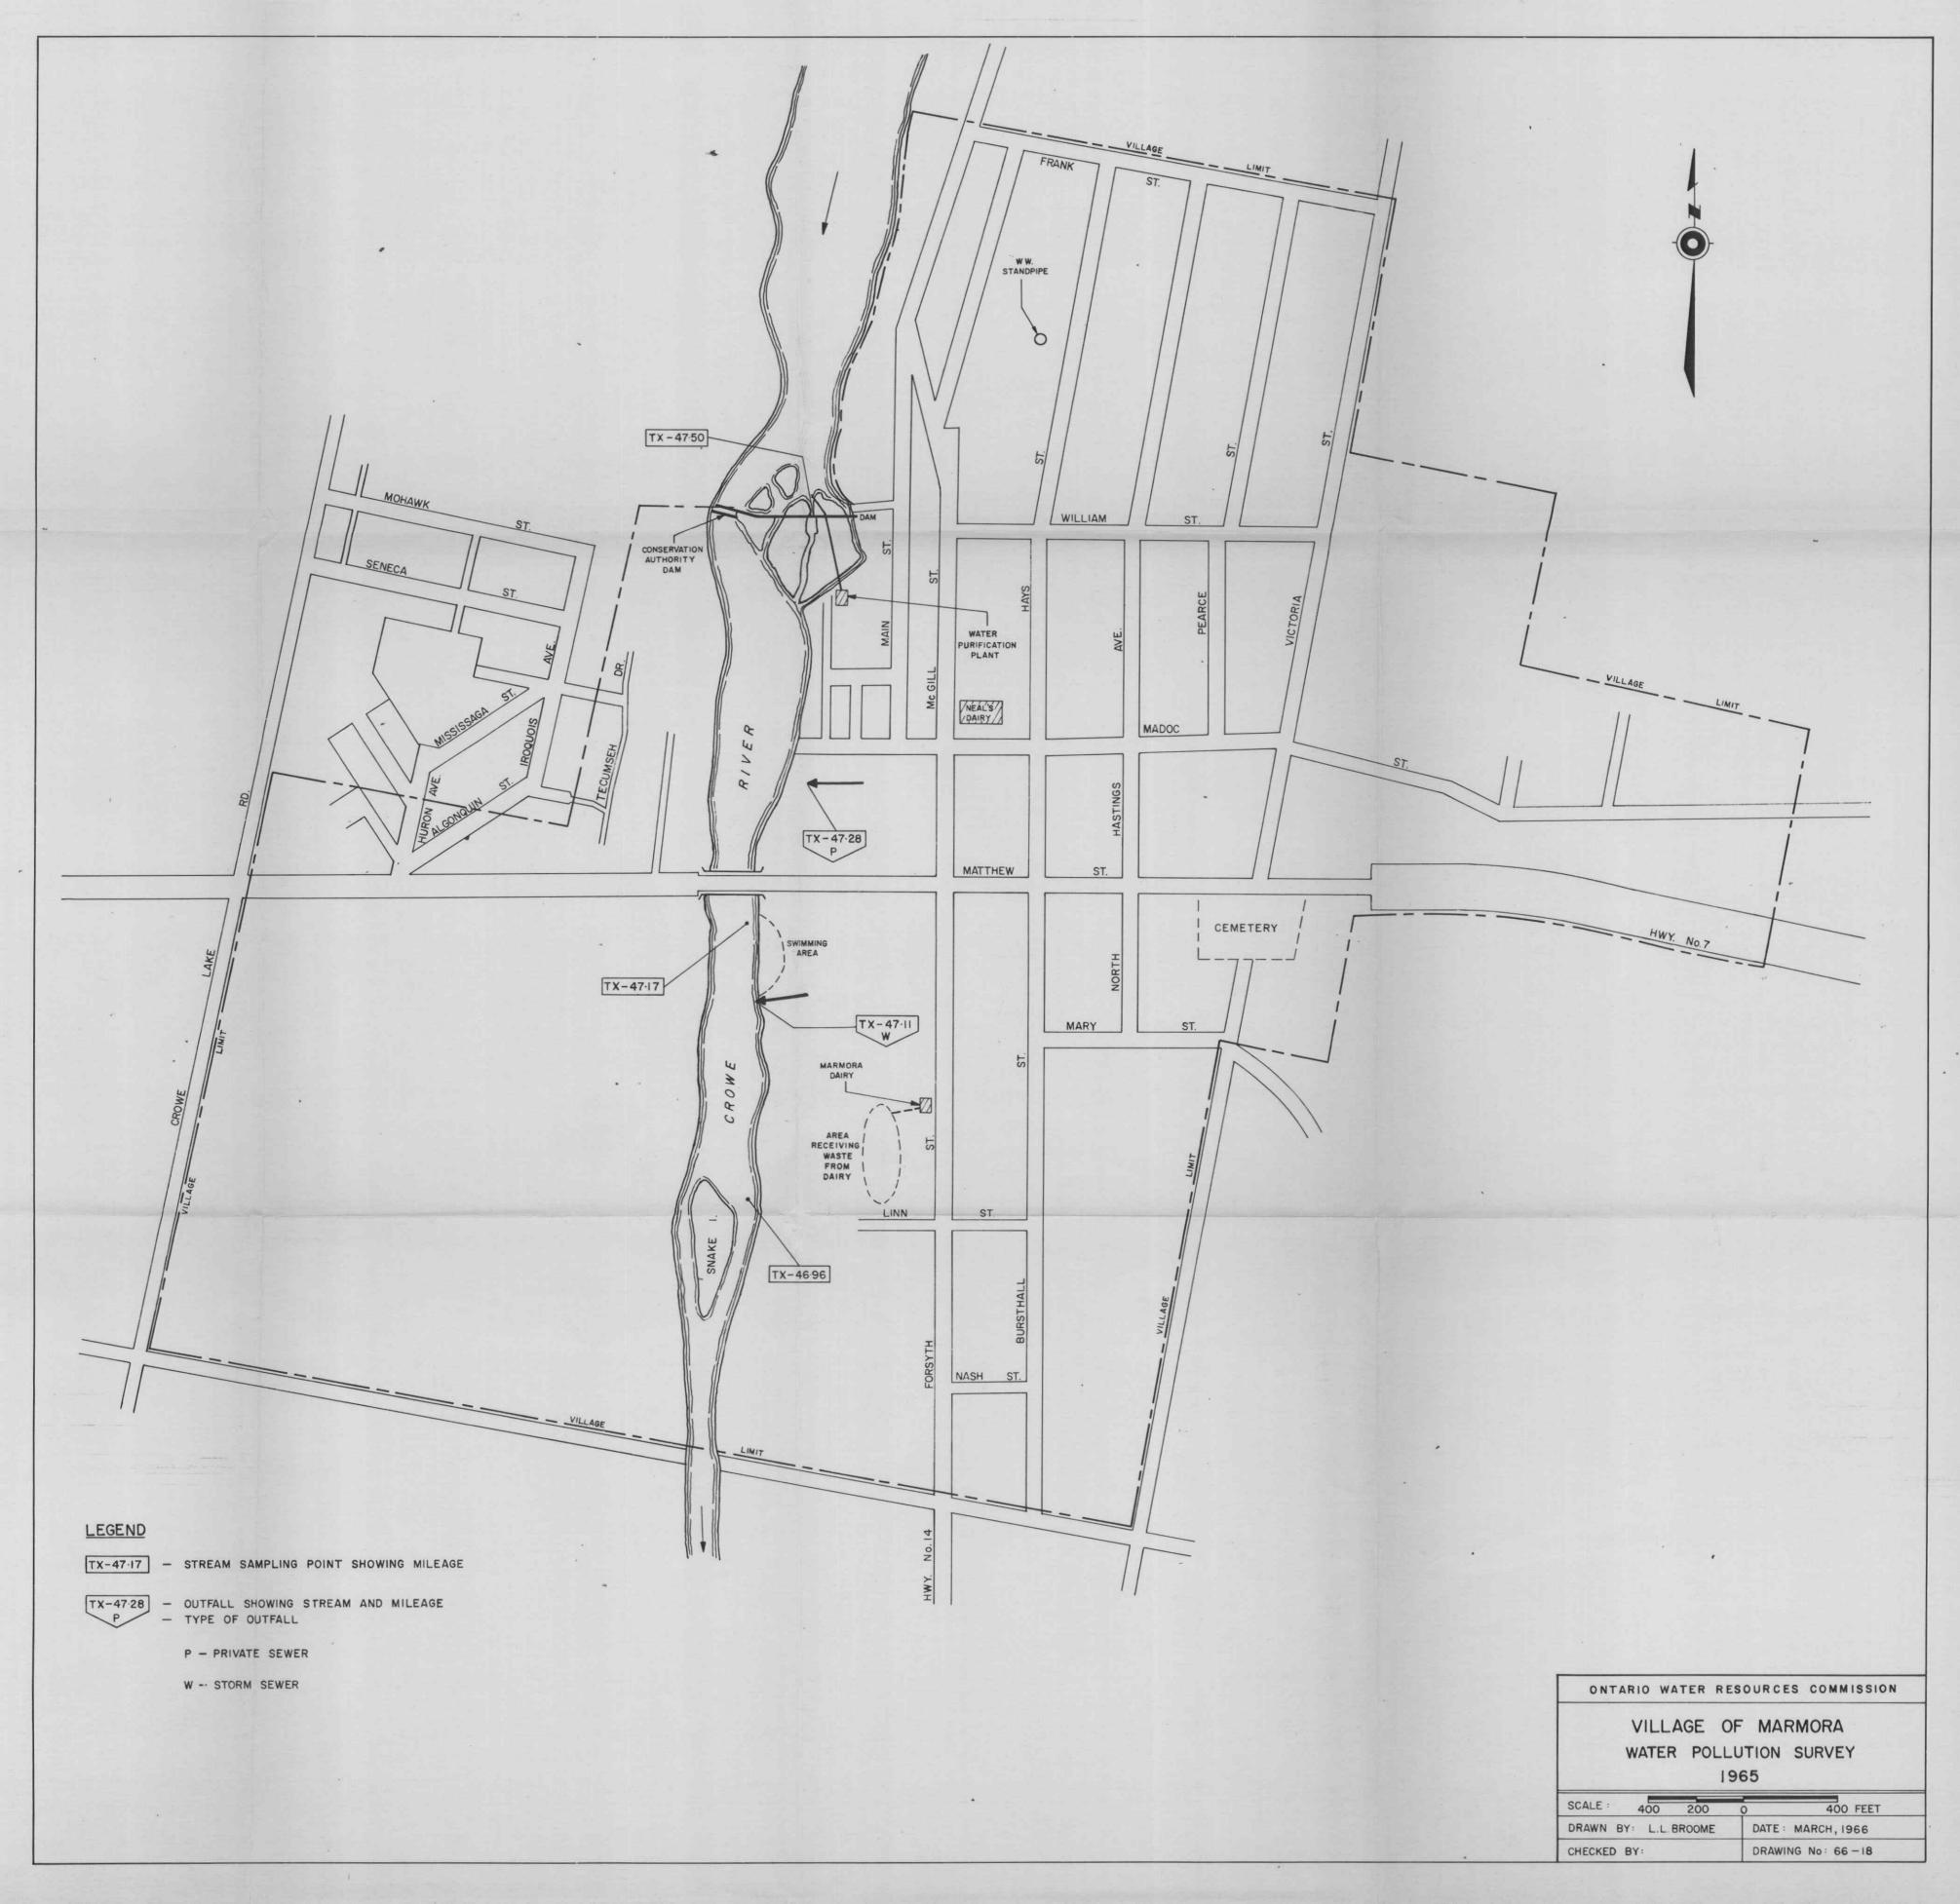
Map of the Village of Marmora

Marmora Dairy and Neal's Dairy are two premises in Marmora which produce waste flows of an industrial nature. The locations are shown on the appended map.

The locations of sampling points are shown on the appended map of the village. The pertinent laboratory results are similarly attached in Tables I and II.
